MINISTRY OF JUSTICE OF THE REPUBLIC OF LITHUANIA  
TRANSPORT ACCIDENT AND INCIDENT INVESTIGATION DIVISION

Accident to ultralight aircraft Bristell UL HD, LY-LIS,  
that occurred on  
8 August 2022  
Armaniškiai village, Kaunas district,  
Republic of Lithuania

## **SAFETY INVESTIGATION REPORT**

No. (A-22/08) 1A-167  
17 September 2024

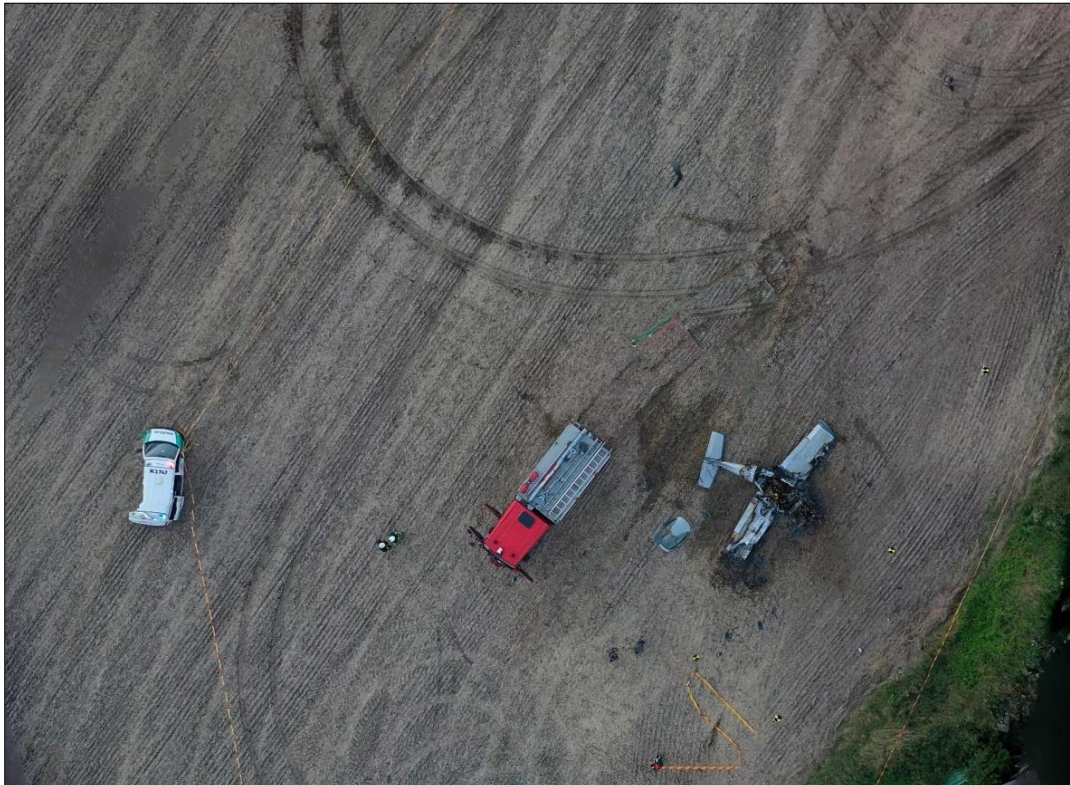
Fig 2. The aircraft Bristell UL HD at the accident site

The aircraft impacted in a cut crop field 4.2 km southwest of the aerodrome reference point in the aerodrome's West pilotage zone. The accident site was located about 40 meters northwest of the residential house, and the aircraft was lying with its nose oriented towards the house. The structural elements of the aircraft were not detached from the aircraft and the wreckage was lying in one place. The canopy was lying separately from the aircraft at about the span of the wing near the tail (Fig. 2).

The leading edges of the aircraft's wings were cracked in the locations of the fuel tanks and the front parts of the wings were burnt. The right wing was severely deformed. The part of the right wing at the fuel tank was burnt, the tip of the wing was burnt out. The leading edge of the left wing was cracked at the place of the fuel tank and burnt. During the impact, the fuel ruptured the wing's leading edge and spilled out in front of the wing.

The landing gear was broken and bent to the left.

The engine was stuck in the ground. The propeller was burnt. The remains of one propeller blade were lying on the ground, the remains (frames) of the other two blades were sticking out.

The safety investigation found no signs of structural failure of the aircraft that could have caused the accident. There was also no evidence that the flight control systems were inoperative. The flight crew did not declare any problems during the flight. All the damage resulted from the aircraft impact to the ground and the post impact fire.
