Final Report
by the Aircraft Accident
Investigation Bureau

concerning the accident

of the Antonov-2 aircraft, LY-KAG

on 15 March 2003

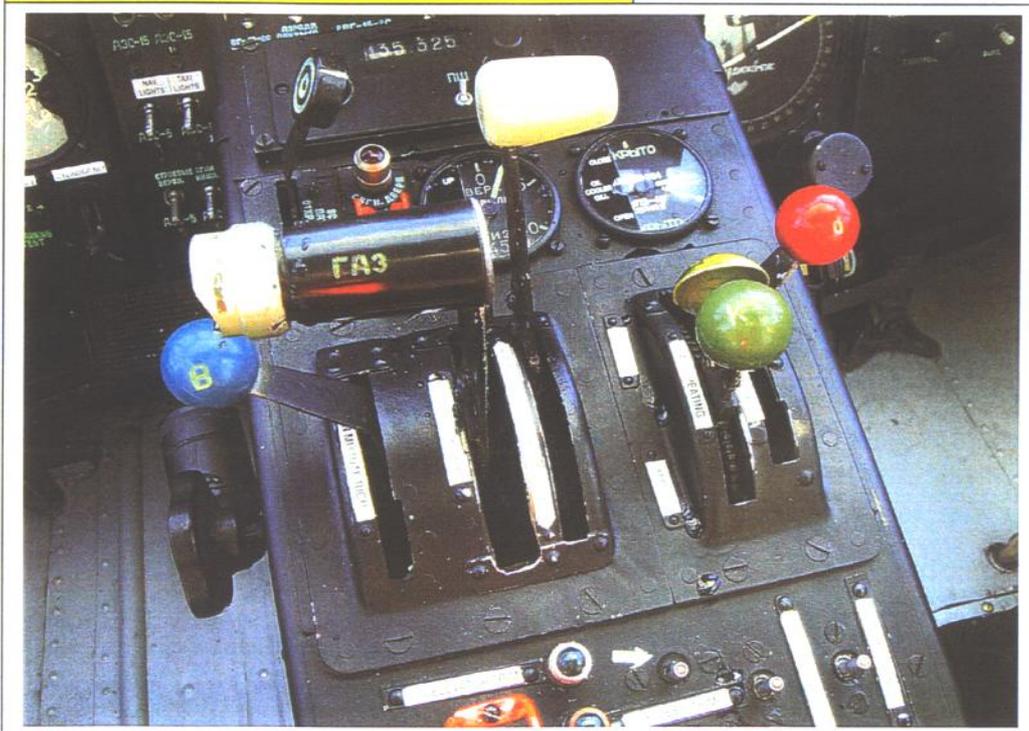
- During the inspection of the cockpit carried out at the beginning of the investigation it was ascertained that the control lever for regulating the mixture was 20 mm in front of the front stop (lean mix) and the control lever for regulating the carburettor temperature was "open" 30 mm in the pre-heating direction.

Hebelstellung nach der Bergung am 16.03.03
