## Investigation report

C 6/2006 L

# Collision of two glider aircraft in Orimattila on 15 July 2006

OH-956 (AC) Sportine Aviacija LAK-17AT

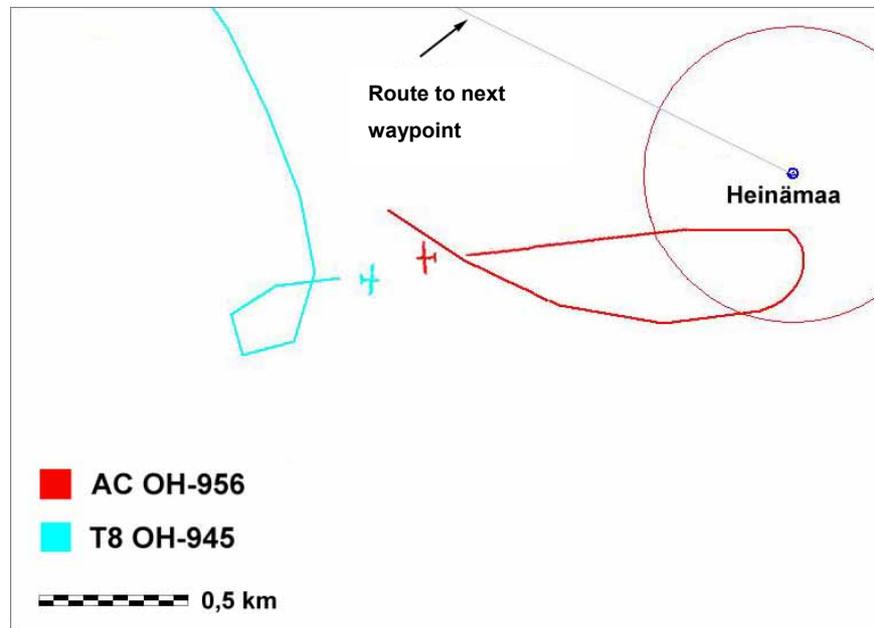
AC approached, in straight and level flight, the lift that T8 had just vacated, with intention of returning to the lift it had flown through earlier when flying to the waypoint. AC reached an area of sustaining lift and the pilot reduced the airspeed by raising the nose, gaining 56 m of altitude during the last GPS data recorder recording interval (18 s). The pilot of AC did not see T8 approaching from the opposite direction. The left wings of the aircraft hit each other at 14:37:15 at an altitude of 1490 m above ground level. The closing speed of the two aircraft was approximately 250 km/h at the time of collision.

At the moment of collision, T8 was turning right to enter a left-hand orbiting lift. The pilot of T8 noticed the approaching aircraft approximately 1–2 s before the impact. The pilot

Figure 1. The situation at the time of collision. AC marked in red and T8 in blue.  
(Volkslogger recorder data)

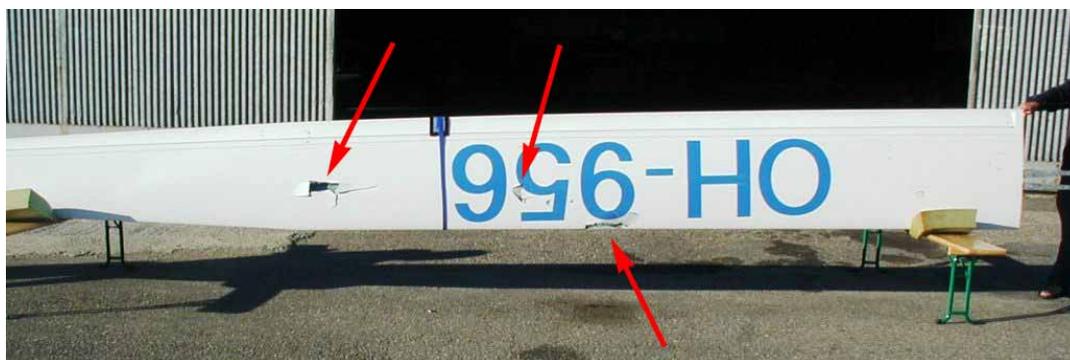
A small crack was found in the paint 2.3 m outboard from the base of the left wing. There were in total three holes on the lower side of the wing in the wing leading edge and in the area between the leading edge and the main spar (fig. 2). Several of the carbon-fibre bundles of the main wing spar had detached at the outermost hole. The main wing spar is exceptionally manufactured from carbon-fibre bundles, 3 mm in diameter and bound together with epoxy resin to form the main spar. A small dent was found in the left wing flap.

Figure 2. AC left wing lower surface. The arrows indicate the holes found on the wing.

There were three holes on the lower surface of the left wing of glider aircraft AC: one in the middle section of the wing in the leading edge; a second in the middle section of the wing between the leading edge and the main spar and a third, larger, hole about 4 m from the wing base. These damages were most likely formed by the separated wing extension of T8 hitting the AC wing lower surface after breaking off.

The first collision impact occurred, when the wingtip of T8 hit the wing leading edge of AC about 2.3 m from the base of the wing, leaving a crack in the AC wing leading edge. The force of the impact tore open the T8 wing extension attachment and the wing extension broke off, swinging around and hitting the lower surface of AC's wing, leaving a blue paint trace from the registration markings of AC on the wing extension. The protrusions in the wing extension caused damages to the wing lower surface, the main spar and the water ballast tanks of AC.

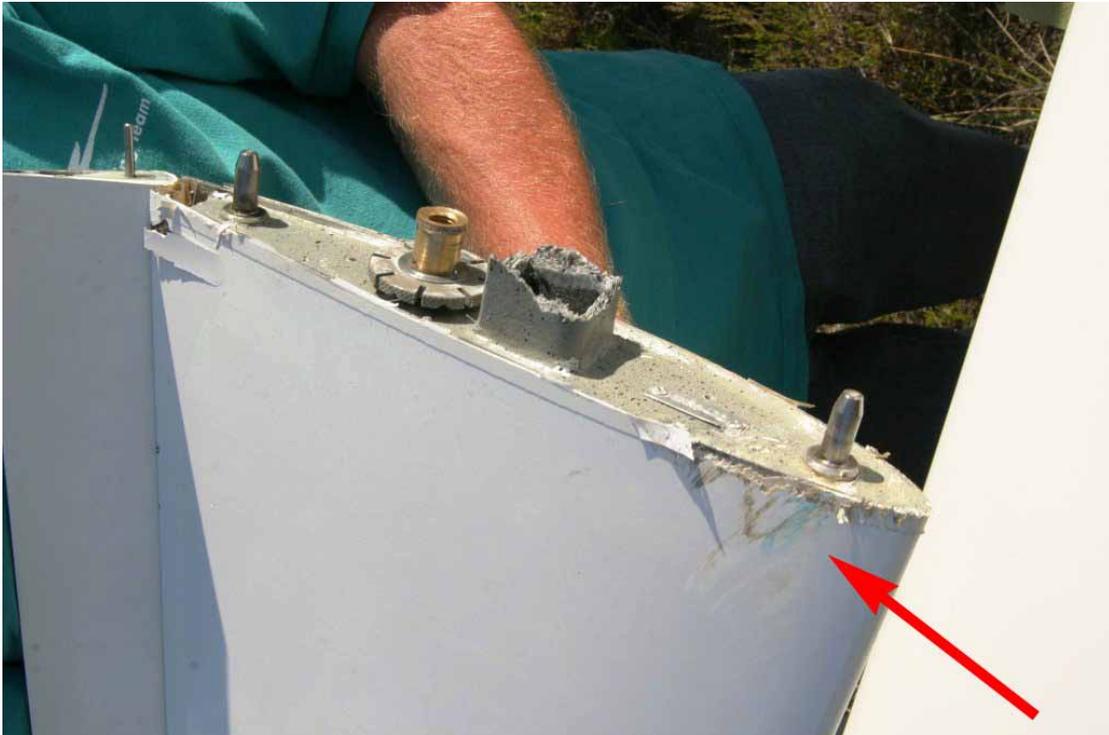
The detachable wing extension (fig. 3) had completely separated from the left wing at its attachment point. The attachment screw had broken at the left wing tip. The wing extension rear attachment metal guiding pin had broken off. The wing extension was crushed at the tip, and a 90 cm section had separated from it. The wing extension aileron adhesive bond was detached for a length of 10 cm at the edge on the base side. The wing extension main spar was broken at the wing base rib. The base rib fore and aft corners were fractured.

There was a trace of blue paint on the lower surface of the separated wing extension. The blue colour was found to be the same as on the AC registration markings on the lower surface of the wing.

Figure 3. The wing base rib of the separated wing extension of T8.  
The blue paint trace on the right is indicated by the arrow.

The left wing extension of glider aircraft T8 was crushed at the wingtip for a length of 90 cm. The wing extension had torn off at the attachment point and the main spar of the wing extension was broken. The left aileron outboard corner adhesive bond had detached.

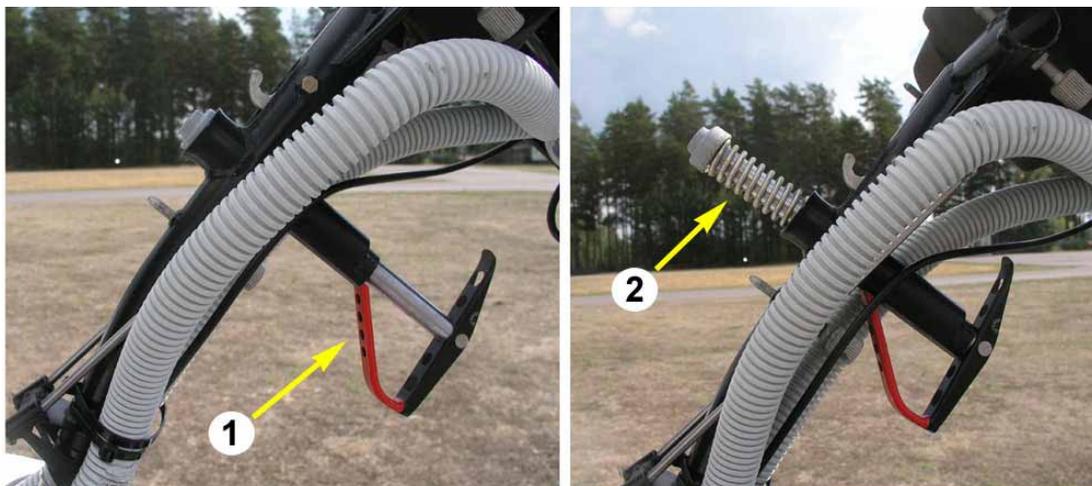
When investigating the canopy jettison mechanism of AC, it was found that it had been operated from the canopy jettison handle in the cockpit. The canopy locks had opened, but the compression spring that pushes the canopy upwards had not activated, because it was incorrectly locked in the canopy mounting position.

There is a compression spring (2) in the canopy locking mechanism, which pushes the front end of the canopy approximately 10 cm upwards and outwards when the canopy jettison handle in the cockpit is operated, allowing the airflow to lift the canopy up and away, clear of the cockpit. For this to take place the compression spring must be in the unlocked (working) position. The locked position is necessary for mounting the canopy, when the spring must be pulled and locked. After mounting the canopy, the spring must be unlocked. There are no markings in the aircraft revealing the correct position of the red locking handle (1) on the spring locking system. On the handle itself, the only marking is the red colour of the handle. There is a warning in the flight manual, the maintenance manual and the pre-flight checklist located in the cockpit, that the spring must be in the unlocked position for the canopy jettison mechanism to function correctly.

Figure 4. The compression spring locking system of the spring-type canopy jettison mechanism. The left-hand picture shows the red locking handle (1) in the locked position for canopy mounting. The right-hand picture shows the compression spring (2) in the extended, canopy jettison position.

The pilot had not fully understood the canopy locking mechanism, and after mounting the canopy had left the spring locking handle incorrectly in the locked position. The locking handle was also found in the locked position in another aircraft of the same type.

The pilot of this second aircraft was also unaware of the correct locking system operation. In the view of the investigation commission, the incorrect position of the locking handle in the aircraft is a consequence of the inadequate instructions in the flight manual concerning the canopy jettison mechanism, as well as the lack of warning markings on, or in the vicinity of, the spring locking handle. Although the inspection of the correct position of the locking handle is mentioned in several different sources, the different positions of the locking handle are clearly depicted in only one diagram of the maintenance manual.

1. The investigation commission recommends, that the manufacturer specify the instructions concerning the canopy jettison mechanism given in the flight manual and the markings on the aircraft in such a way that the correct position of the spring locking system is evident and unambiguous.
