# **FINAL REPORT**

## **Investigation into the accident**

**collision of LAK 12,  
registration OK-1212  
with a tow rope  
suspended from the Rallye 180T-D registration D-ESKH  
at 3 km NNE LKHS  
on 14 August 2013**

**Prague  
August 2013**

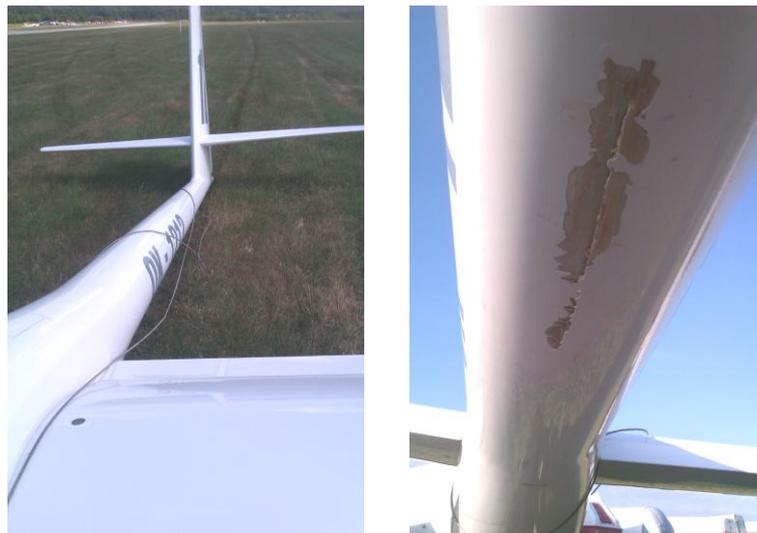
Figure 1 Status of the LAK 12 fuselage after the collision.

- the meteorological conditions were no aspect relevant to the emergence and development of the incident,
- the pilot of the glider tug did not ascertain that the aerotow trajectory crosses the one of another glider flying in from the right on an approximately identical flight level,
- the OK-1212 glider pilot most likely did not see the approaching aerotow in time due to the mutual positioning during the glide and the cockpit lookout angle,
- no aircraft section was detached from the OK-1212 glider; the glider was controllable even though the tow rope remained caught in its fuselage.

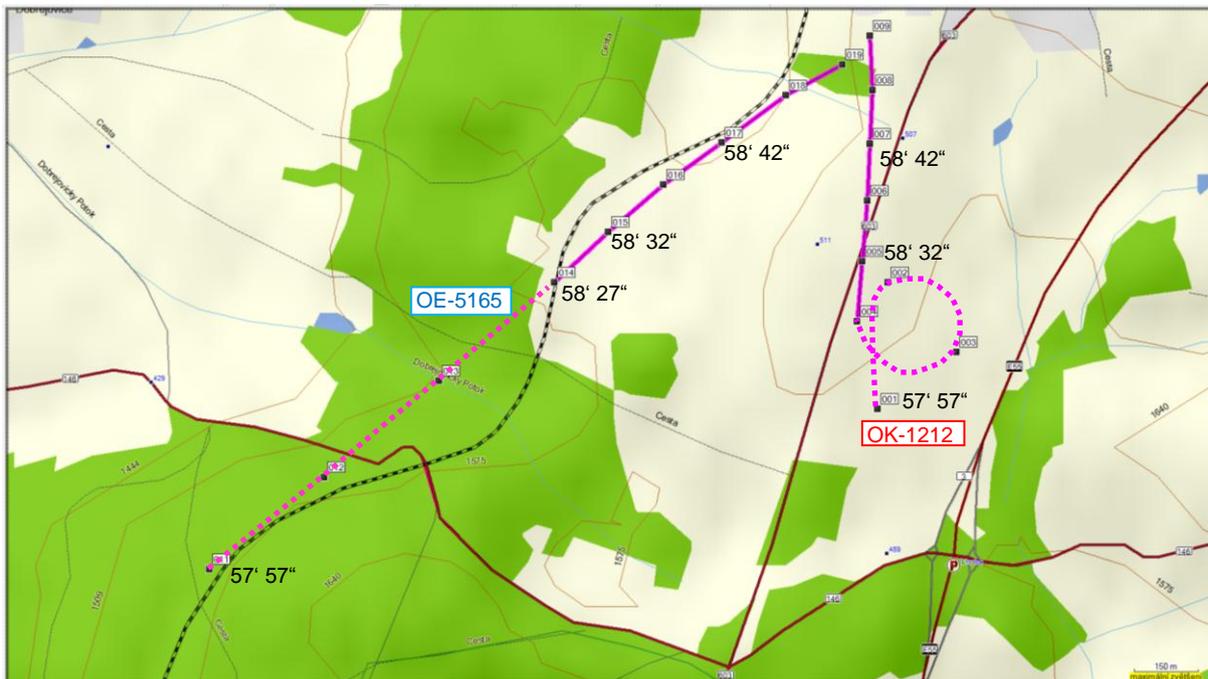
right-of-way pursuant to the rules of collision avoidance. At the time of finishing the 360 degrees right-turn, the glider was approximately by 70 m higher and to the right in relation to the aerotow, with separation of approx. 714 m. Consequently, due to the trajectories convergence and the aerotow's climb, the horizontal as well as vertical separation was reduced. The geometry of the trajectories implies that approx. 20 seconds before the collision the glider was approx. 45 degrees to the left from the trajectory of the glider tug with a minimum clearance and in separation of 600 m. Approx. 10 seconds before the collision it was in separation of 350 m under the angle of 35 degrees to the left and approx. 5 seconds before the collision it was 200 m to the left at 25 degrees.

Figure 2 Diagram showing relative locations of OK-1212 prior to the collision with D-ESKH.

The collision occurred at a relative closure speed of approx.  $135 \text{ km}\cdot\text{h}^{-1}$  because the glider tug pilot whose attention was, on a very high level of probability, distracted and not distributed evenly between monitoring the glider in the tow and the operation in the vicinity of his aircraft. During the glide after the right-hand turn swing, the glider pilot spotted the aerotow, probably due to the limited cockpit view angle, only when he noticed the engine noise.

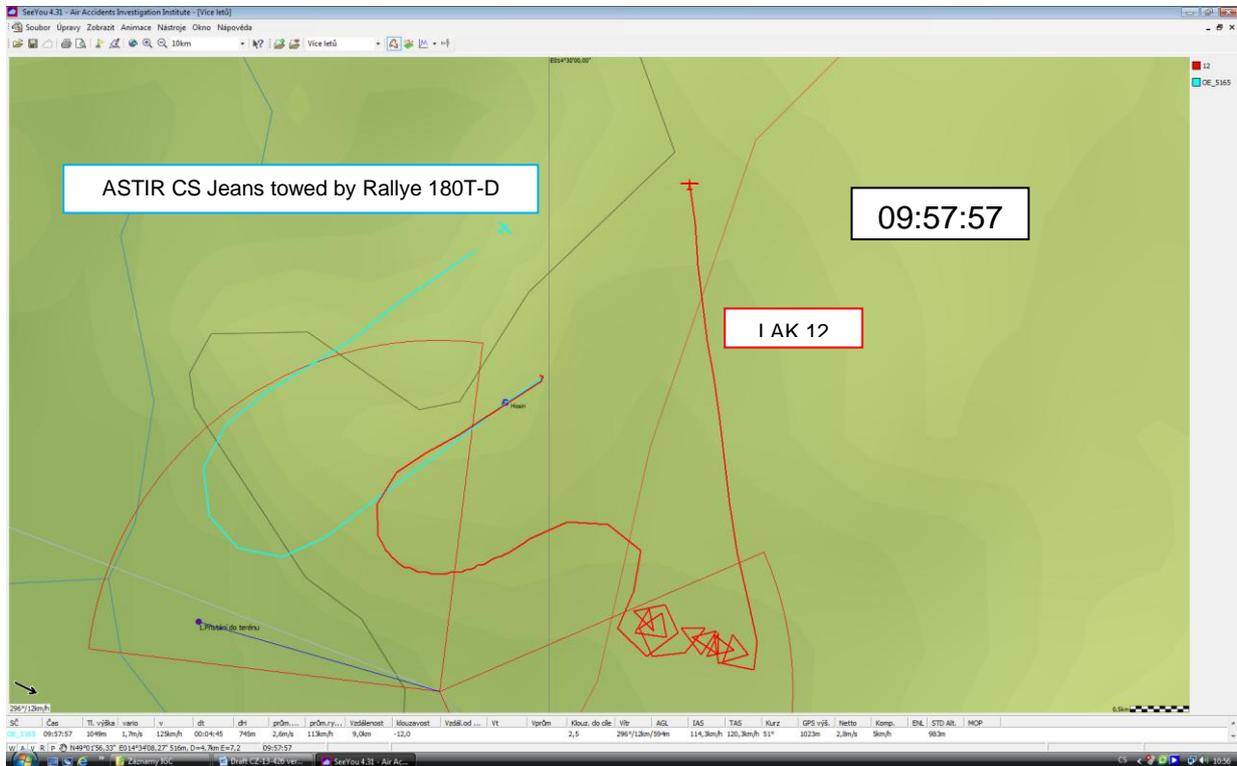
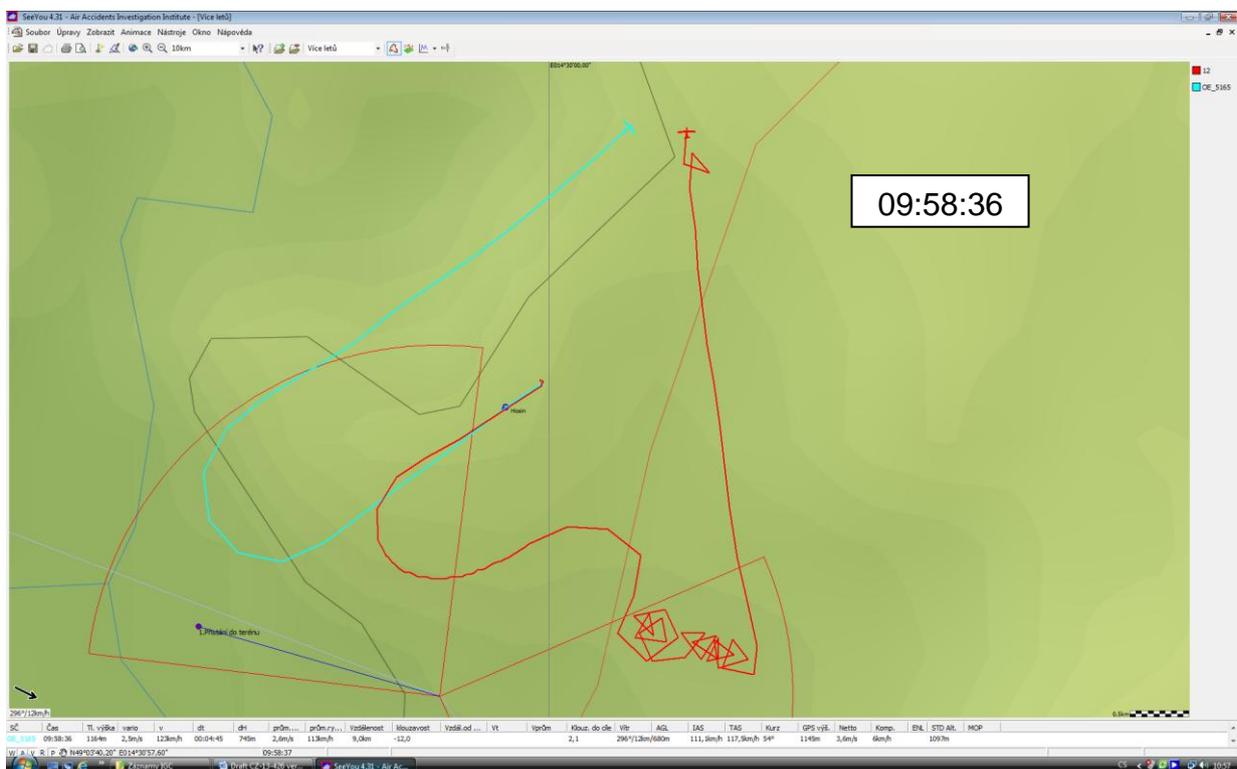
# Appendix 1

Diagram showing trajectory of the glider LAK 12 and OE-5165 (towed by D-ESKH)
