# Technical report

## A-023/2020

Accident involving a TECNAM P2002-JF aircraft operated by BAA Training, registration LY-FTC, at Lleida-Alguaire Airport (Lleida, SPAIN) on 9 July 2020

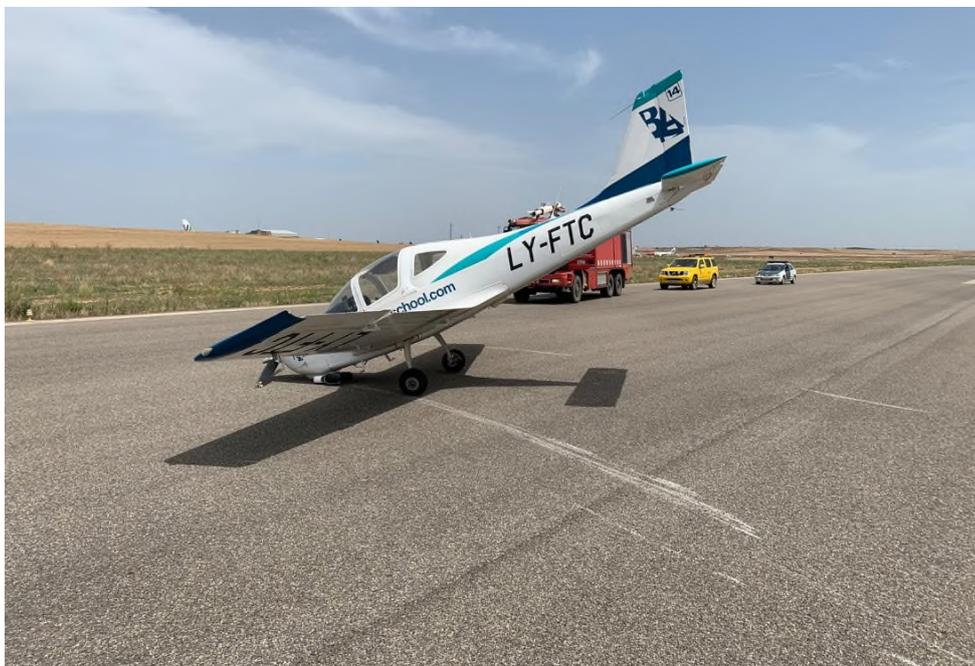
The student pilot was unharmed and was able to exit the aircraft without assistance. The aircraft sustained significant damage.

Fig. 1: Lateral view of the aircraft after the accident

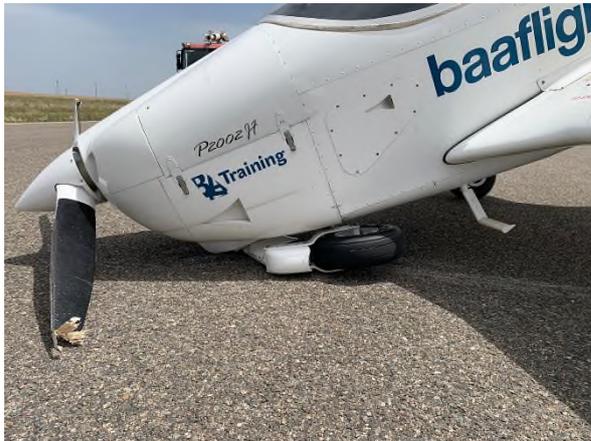
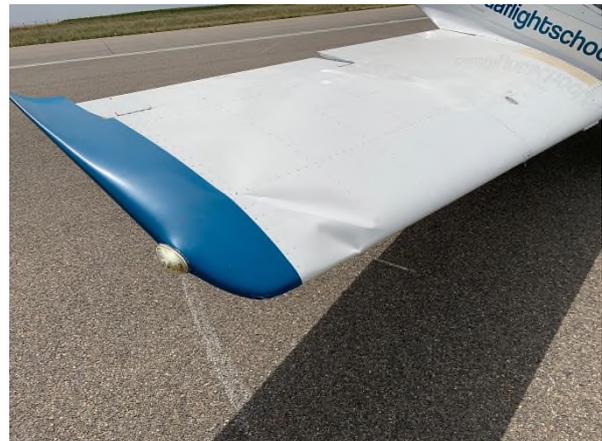
- Propeller
- Damage to engine
- Lower engine cowling
- Nose gear leg broken
- Engine mount
- Right wingtip

Figs. 2 & 3: Damage to the front of the aircraft and the tip of the right wing

As a result of sliding along the runway, the aircraft sustained damage to its propeller, engine, lower engine cowling, nose gear leg, engine mount and right wingtip.

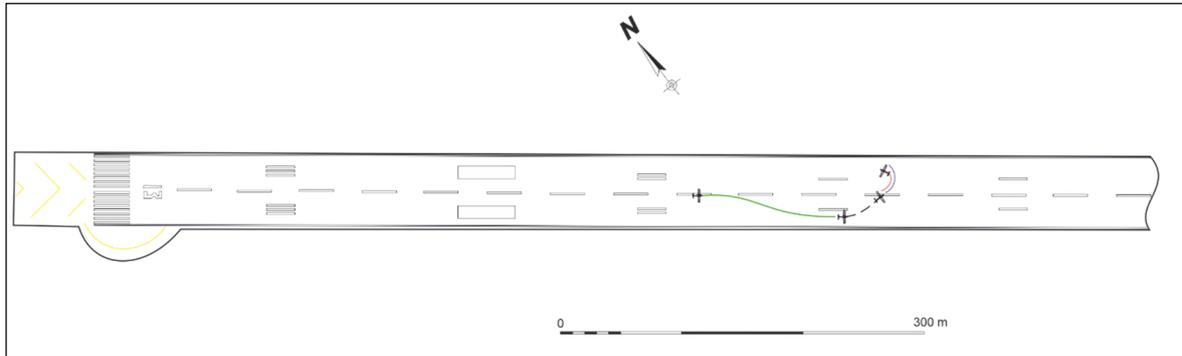
The aircraft landed on runway 13 at Lleida-Alguaire Airport. After its nose wheel collapsed, it slid along the asphalt before coming to a halt while still on the runway. In its final position, it was orientated at approximately  $355^\circ$ , with 13.4 m between the propeller cone and the edge of the runway.

Fig. 4: General sketch

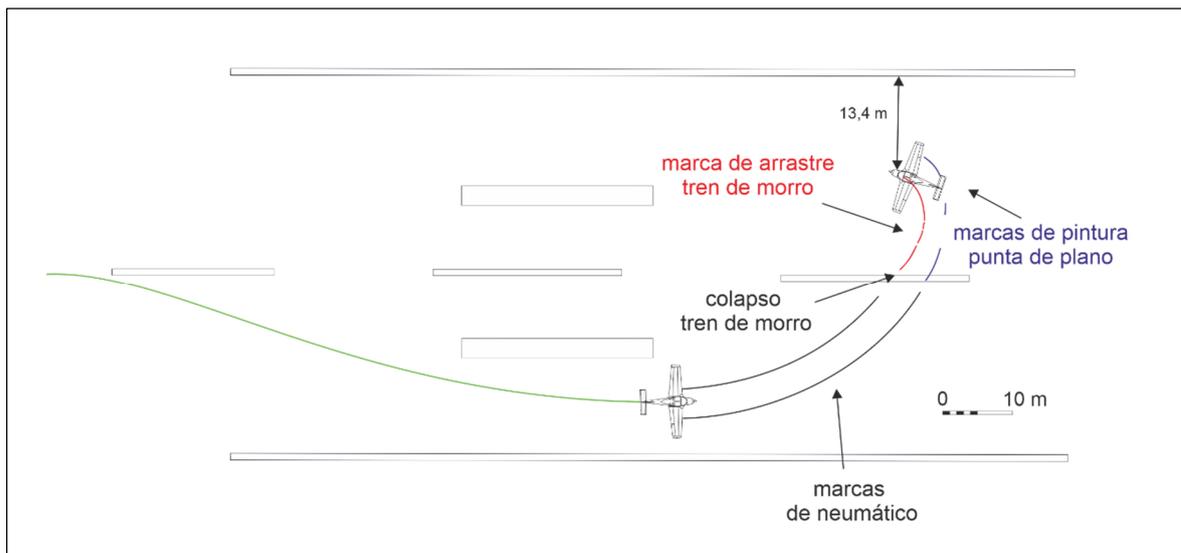
Fig. 5: Detailed sketch

Taking into account the pilot's statement and the marks the aircraft left on the runway, it appears it initially veered to the right after the brakes were applied but then made a sharp left turn that caused the tip of the right wing to hit the runway several times and the nose gear leg to collapse.

The aircraft slid along the runway before coming to a complete stop. The sketch in figure 5 shows the marks left on the runway by the tyres, the right wingtip, and the nose gear as it slid along the ground.
