# Technical report

## IN-011/2022

Incident on 9 March 2022 involving a Tecnam P2006T, registration 5B-CLR, at Lleida-Alguaire Airport (Lleida, Spain)

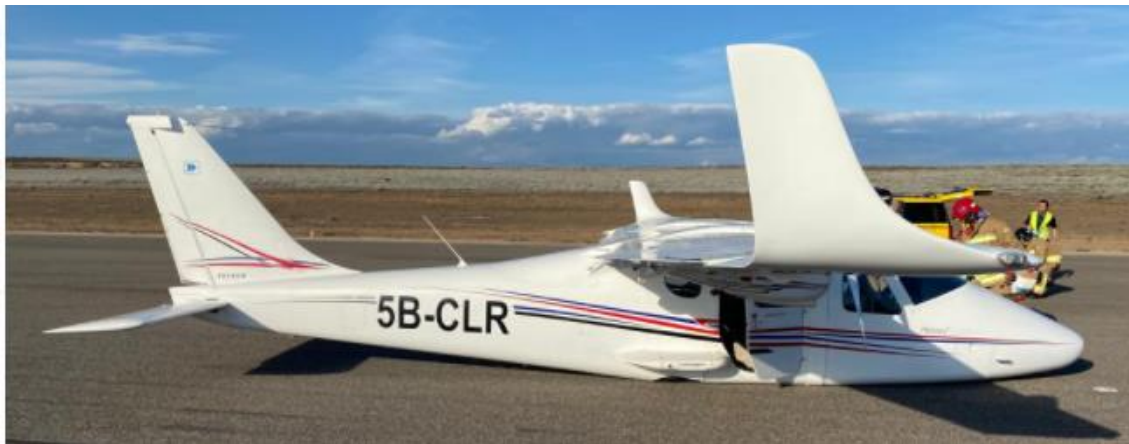
After landing without having extended the landing gear, the aircraft came to rest on the runway, as shown in the photograph:

*Image 2: The aircraft immediately after landing without deploying the landing gear*

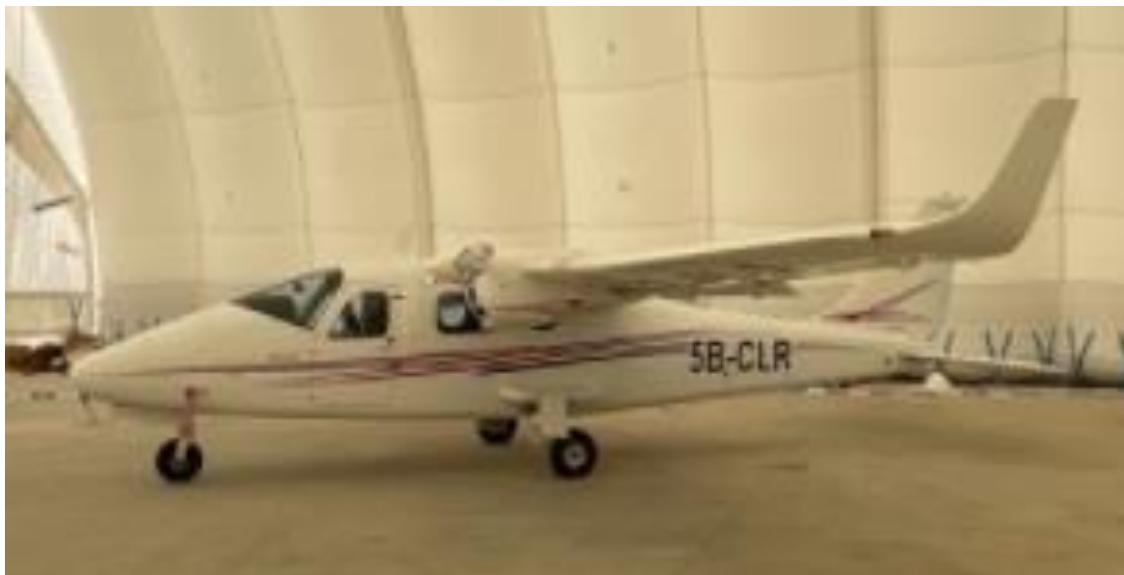
*Image 3: The aircraft after extending the landing gear*

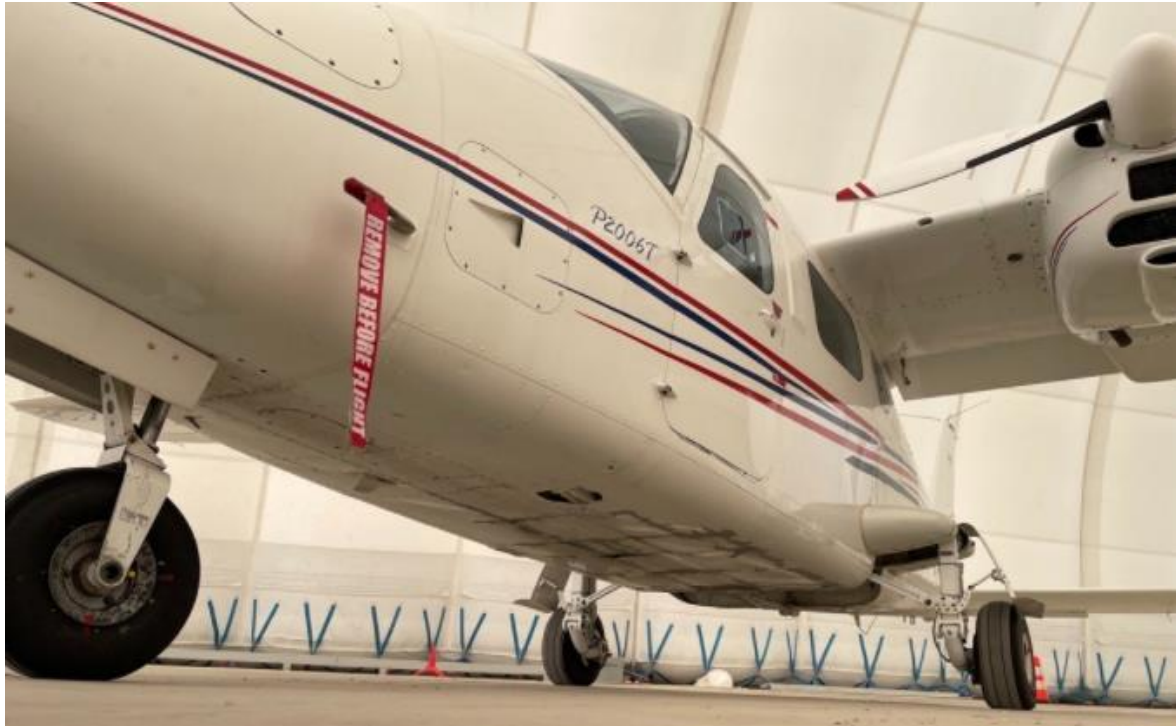
The aircraft sustained damage to the lower fuselage as a result of landing without having deployed the landing gear.

The damage was concentrated on the underside of the fuselage:

Image 4: Condition of the underside of the aircraft's fuselage
