# Technical report

## IN-011/2022

Incident on 9 March 2022 involving a Tecnam P2006T, registration 5B-CLR, at Lleida-Alguaire Airport (Lleida, Spain)

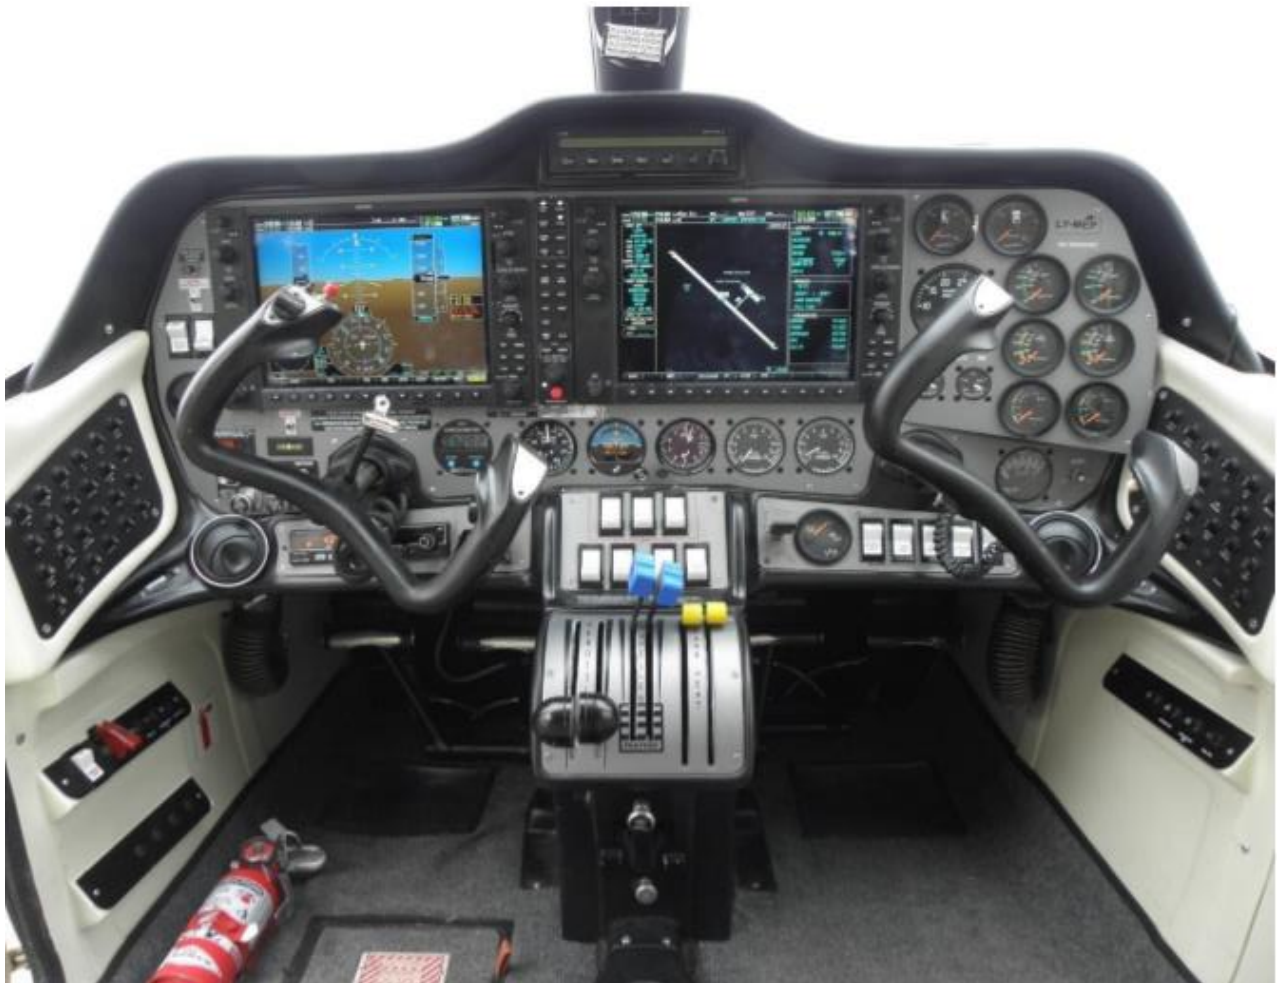
*Image 1: Instrument panel on board the aircraft*

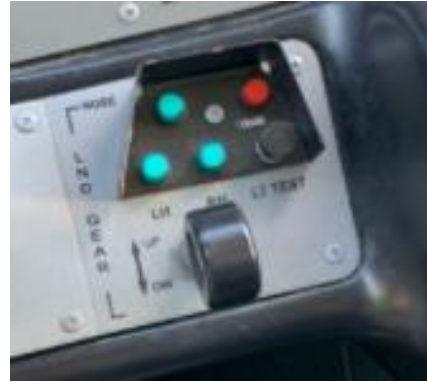
The system has a series of indicator lights that tell the pilot what position the landing gear is in:

- 3 green leg position lights. If lit, they indicate that the landing gear is extended and locked.
- 1 red transition light. If lit, it indicates that the landing gear is in the transition phase.
- 1 amber pump light on the annunciator panel, illuminated whenever the pump has a power supply.
- UP/DOWN micro-switches (two for each leg).
- Operation check push button: to check if the red light and the 3 green lights are working correctly.
